THE
ONTARIO WATER RESOURCES
COMMISSION

Report on
WATER POLLUTION SURVEY

of the
VILLAGE OF LAKEFIELD
in the
COUNTY OF PETERBOROUGH

Division of Sanitary Engineering
August 25, 1964

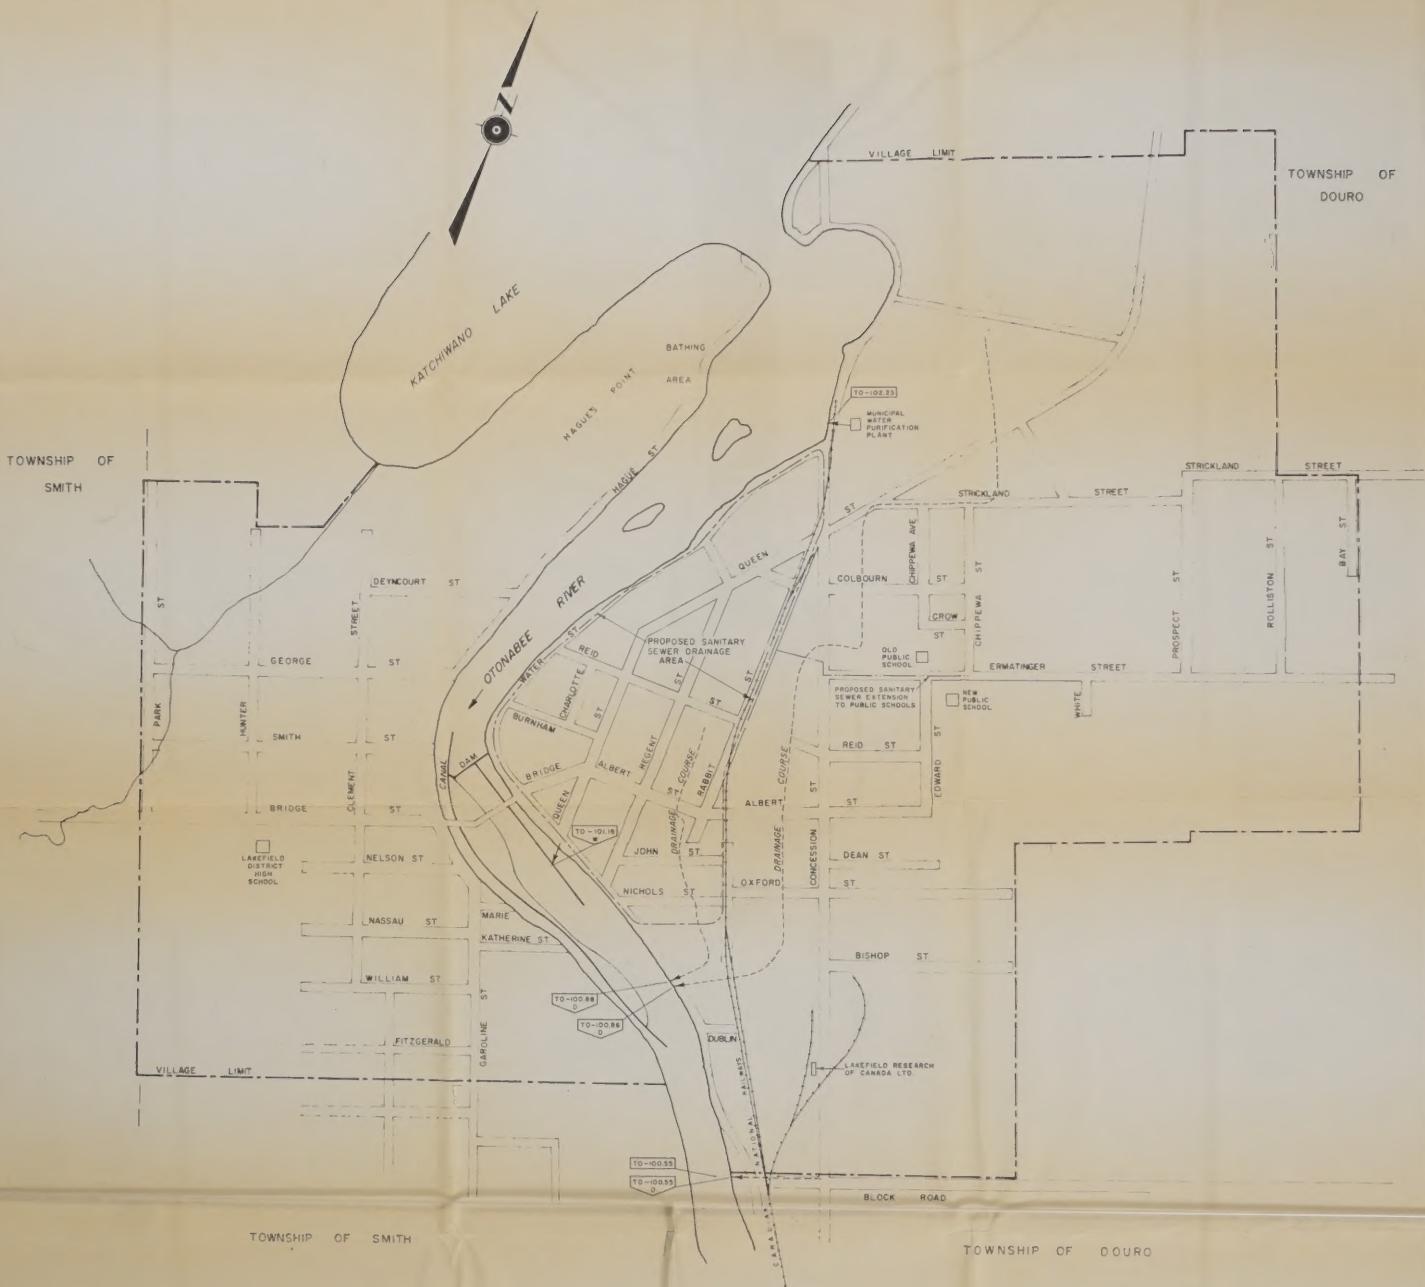
VILLAGE OF LAKEFIELD

As shown on the appended map, the old and the new premises of the Lakefield Public School are located on Ermatinger Street in the eastern part of the municipality. It has been reported to Commission staff on several occasions that sanitary waste from the tile bed system at the public school was gaining access to the municipal drainage course which empties into the Otonabee River at sampling point T0.100.86 D.

Mr. H. T. Hill, Clerk-Treasurer, reported on August 25 that the present sewerage plan would provide service to a section of the village lying on the east side of the Otonabee River. The outline of this sewer area is shown on the appended map. The proposed area lies generally between Rabbit Street and the river, including the principal commercial section, part of

Samples were collected from the waters of the Otonabee River in Lakefield, as well as from outfalls discharging thereto within the corporation boundaries. Appended to this report is a map showing the locations of sampling points. The pertinent laboratory results are attached also.
